Landsat Science Team

Landsat Operations Report

3 Feb 2015

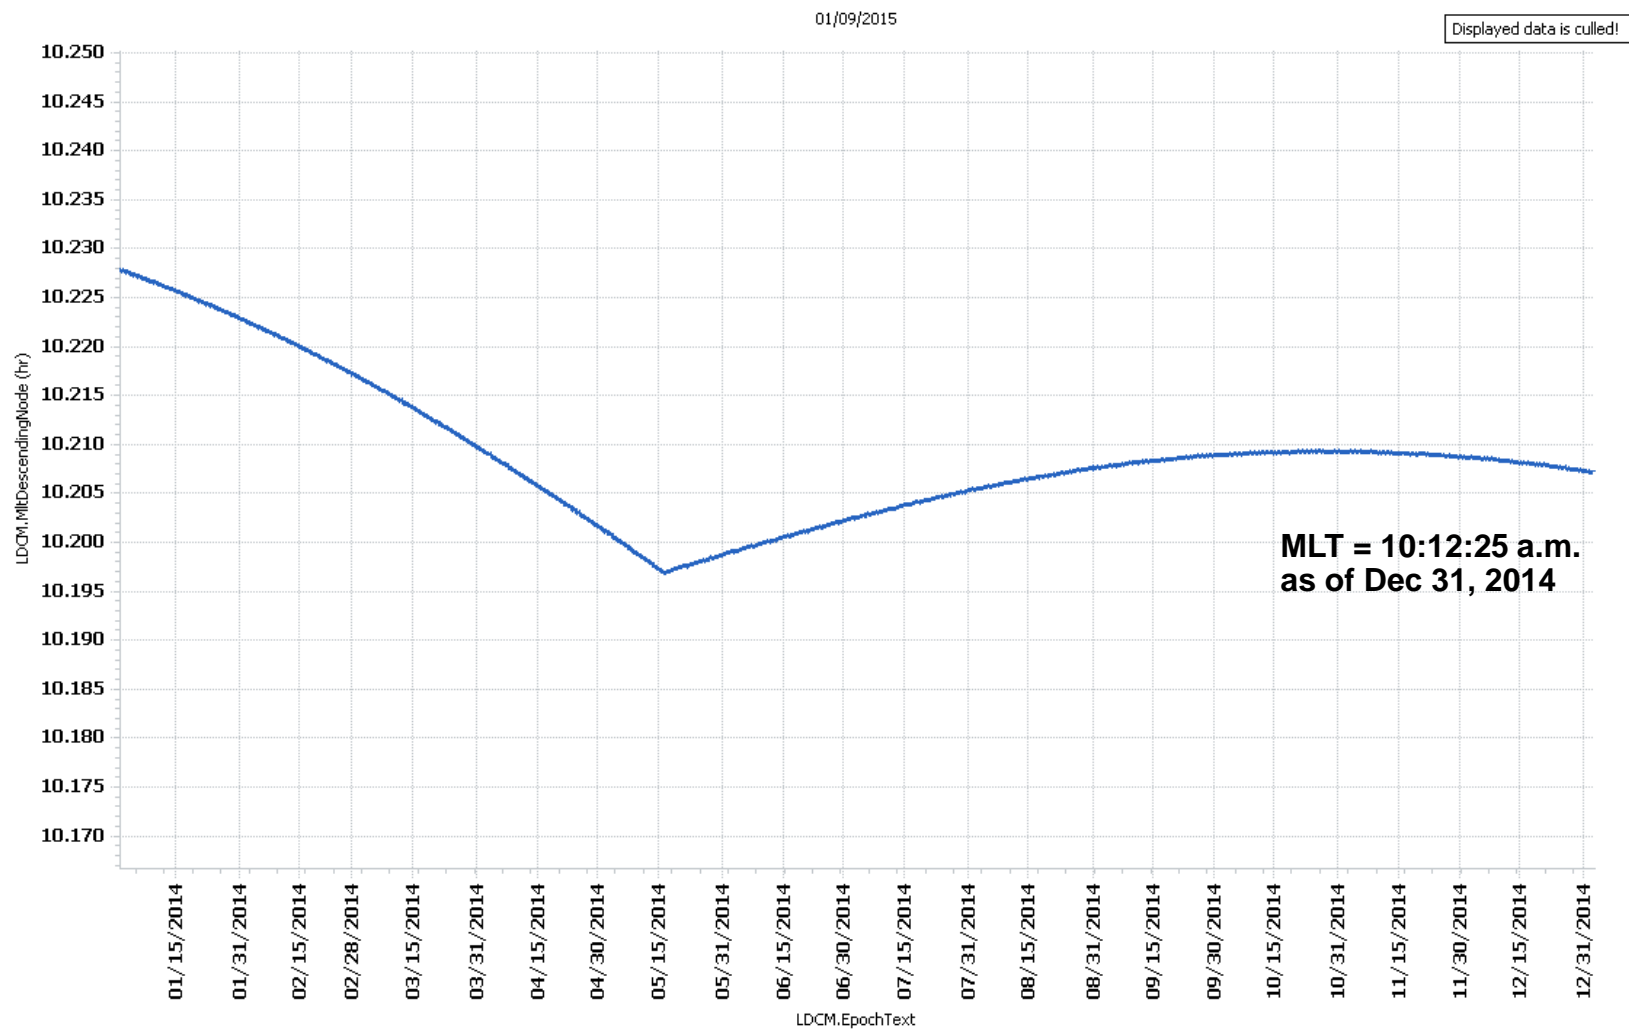
Landsat 8 MLT

Jan 1, 2014 through Dec 31, 2014
